Incomplete cusp fractures: Early diagnosis and communication with patients using fiber-optic transillumination and intraoral photography

Samer S. Alassaad, DDS

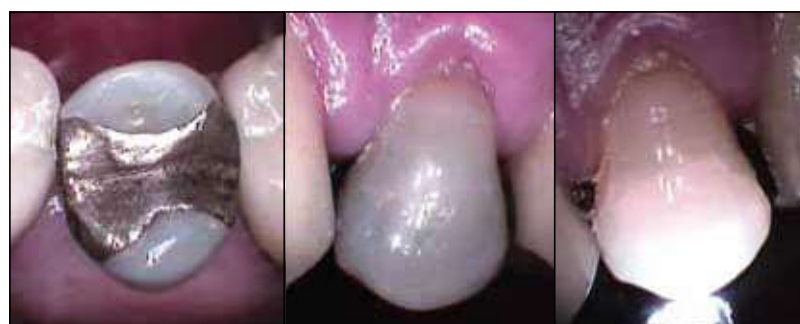
Fig. 1. Maxillary second premolar. *Left:* Occlusal view of cusps weakened by an intracoronal metallic restoration. *Center:* Buccal view. *Right:* Buccal view of a transilluminated buccal cusp showing an incomplete fracture.

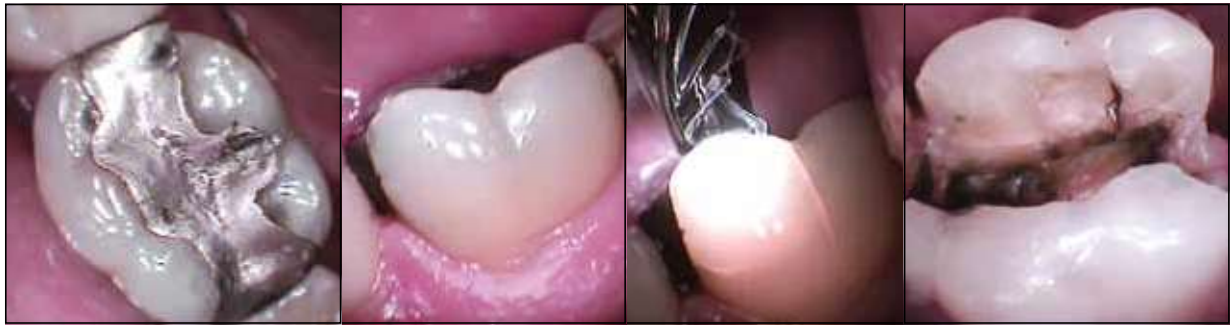
Fig. 2. Mandibular first molar. *Far left:* Occlusal view. *Center left:* Lingual view. *Center right:* Lingual view of a transilluminated mesiolingual cusp. An oblique fracture warrants further investigation. *Far right:* Oblique fracture involving both mesiolingual and distolingual cusps viewed under the light source of the intraoral camera.

Once an incomplete cusp fracture is identified, removing the existing restoration together with its liner and any present caries is recommended to directly visualize the extension of the fracture.^{1,8} Oblique fractures usually will be visible at internal line angles of the preparation. Some of these fractures can appear lighter than the rest of the tooth structure due to refraction of the illuminating light of the operator or the intraoral camera along the fracture line (Fig. 2). Old fractures under metallic restorations may be accentuated due to the presence of stains

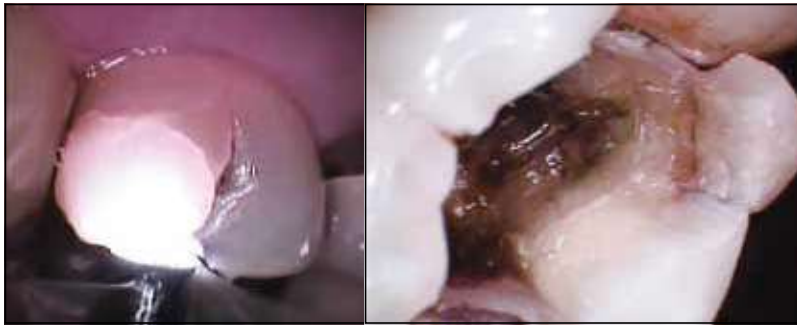
Fig. 3. Maxillary second molar. *Left:* Lingual view of a transilluminated distolingual cusp. *Right:* Intracoronal surface of a distolingual cusp. An old fracture is accentuated by the presence of a stain.

(Fig. 3). However, the extension of some other fractures may be determined only by fiber-optic light transillumination (Fig. 4).

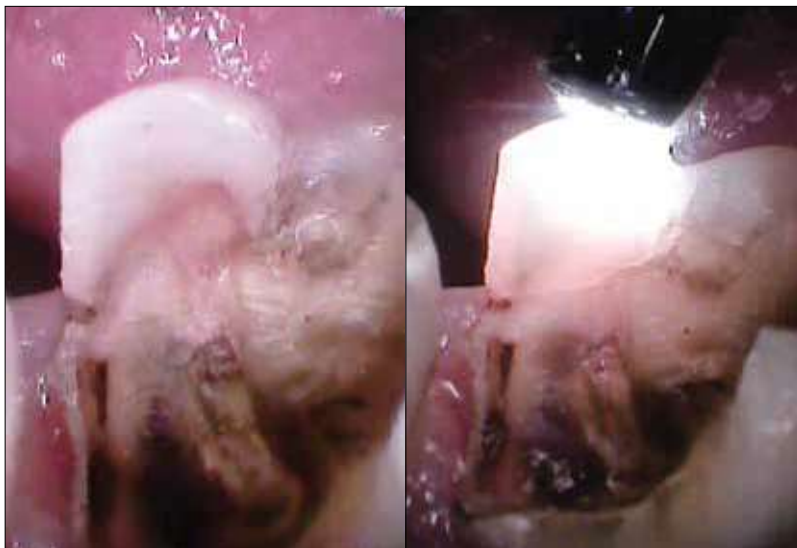
Fig. 4. Intracoronal surface of a mesiolingual cusp on a mandibular first molar. *Left:* The oblique fracture is not completely visible under the light source of the intraoral camera. *Right:* The extension of the oblique fracture is more visible with fiber-optic transillumination.
